# Data Center Northern Virginia

## SCOPE & TESTING

## OVERVIEW

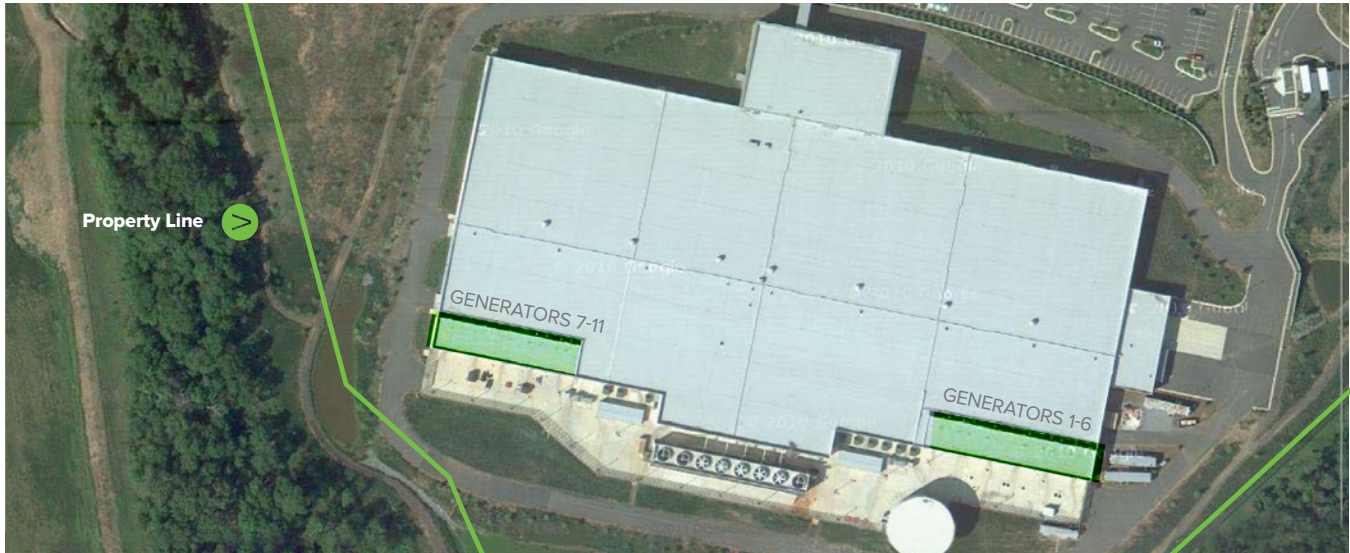
County vs Measured Sound Pressure Levels at Property Lines (dB re: 20 microPa)										
Octave Band Center Freq. (Hz)	0 31.5	1 63	2 125	3 250	4 500	5 1000	6 2000	7 4000	8 8000	dBA <sup>1</sup>
County Regulations	70	72	70	65	59	55	51	47	44	62
Fence Line Measured	75	73	90	86	80	75	71	63	71	83

(1) Overall dBA presented for general intent only; dBA is not part of regulation

With no noise control system in place, the generator system sound levels reached 83 dBA at the property line, violating county regulations. At 108 dBA in the equipment yard, workers were forced to wear ear protection.
