St. Mark's Hospital Salt Lake Ci Utah

Generator Solution

SCOPE & SUCCESS

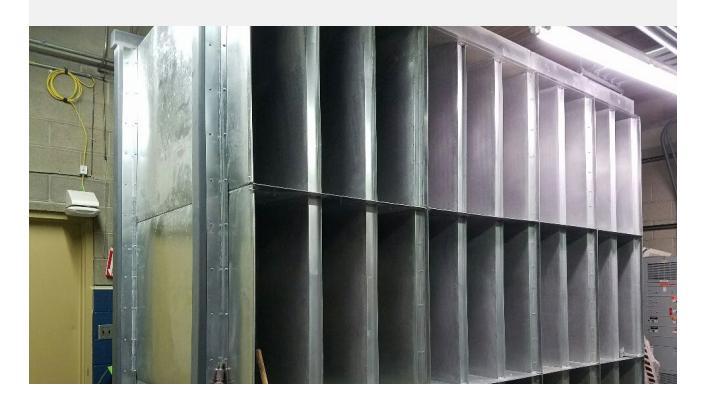
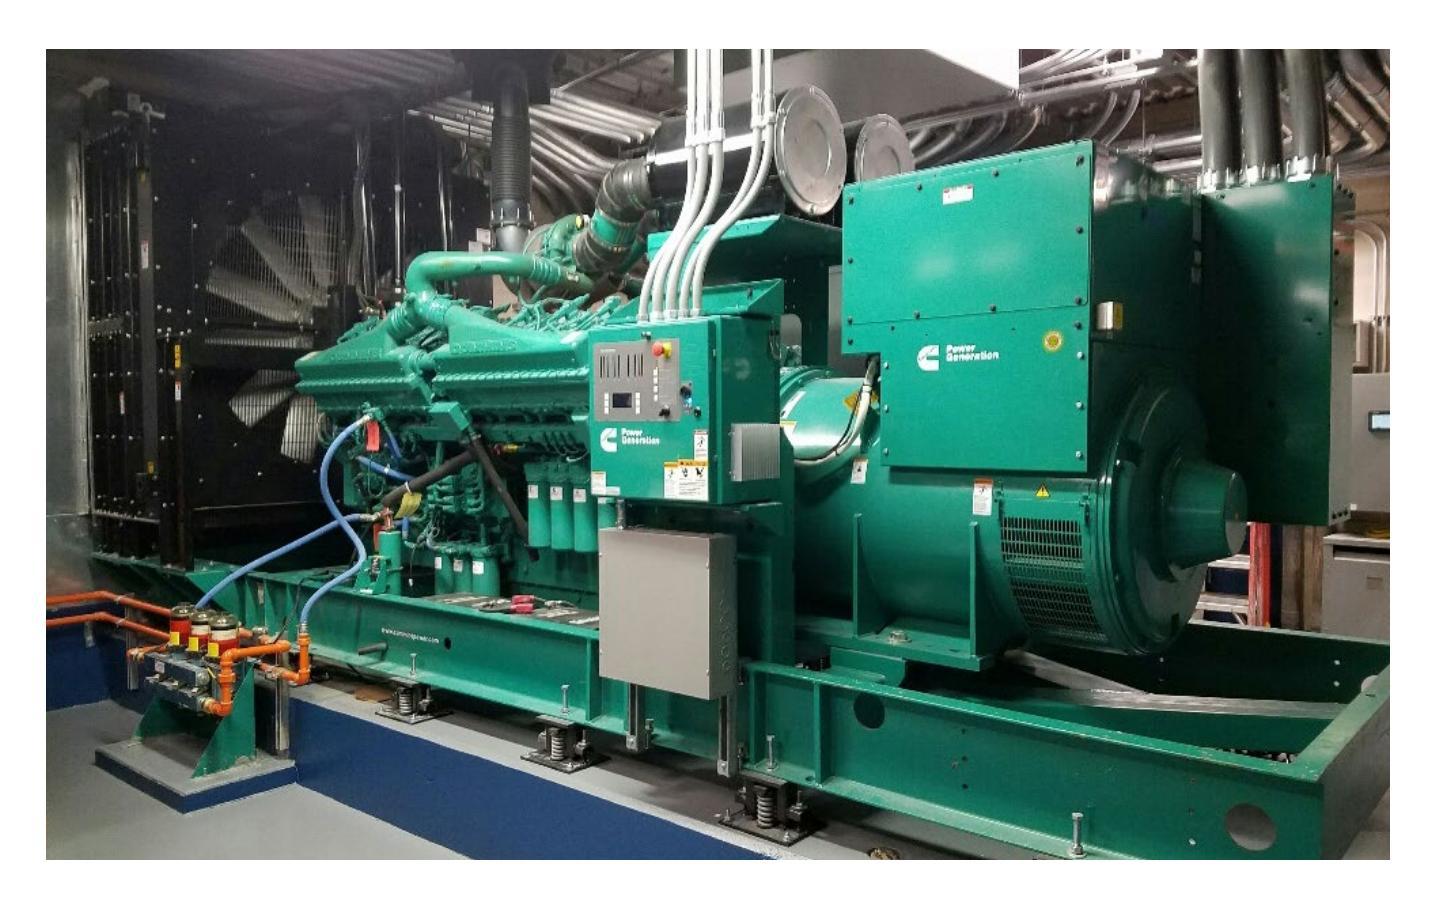
Silencers were also placed at the Generator air exhaust. Since the generator room did not have enough space in it, silencers were placed outside the generator room in the open. The walls of the silencer were covered with acoustic panels to control breakout noise. Existing air devices were reused with the silencers. To control radiant and reverberant noise, acoustic panels were installed on the inner walls of the generator room. Acoustic panels were also installed on the concrete wall at the property line.

The combined pressure drop of the intake and exhaust silencers was less than 0.3" WG, which was less than the 0.5'WG pressure drop allowed by the generator manufacturer.
